Inspector: Katie Helton

Investigation Date/Time: 12/5/2017 9:30 AM

Facility: SolowPower Permit# 433.051

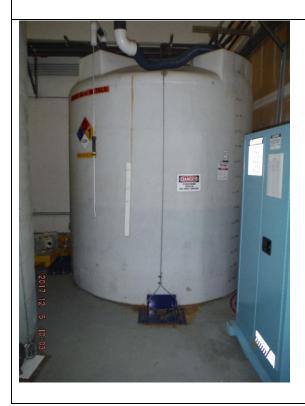
Remaining wastewater in storage tanks prior to to being treated. According to of SoloPower, tank on left and right are closer to a base with metals.

Remaining acidic metals wastewater prior to being treated.

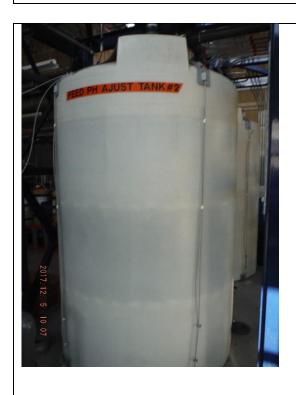
Wastewater still in the pH adjustment tank.
